Could Zinc Whiskers Be Impacting Your Electronic Systems? Raise Your Awareness

Jay Brusse
QSS Group, Inc.
Greenbelt, MD
Jay.A.Brusse.1@gsfc.nasa.gov

Michael Sampson
NASA Goddard Space Flight Center
Greenbelt, MD
Michael.J.Sampson@nasa.gov

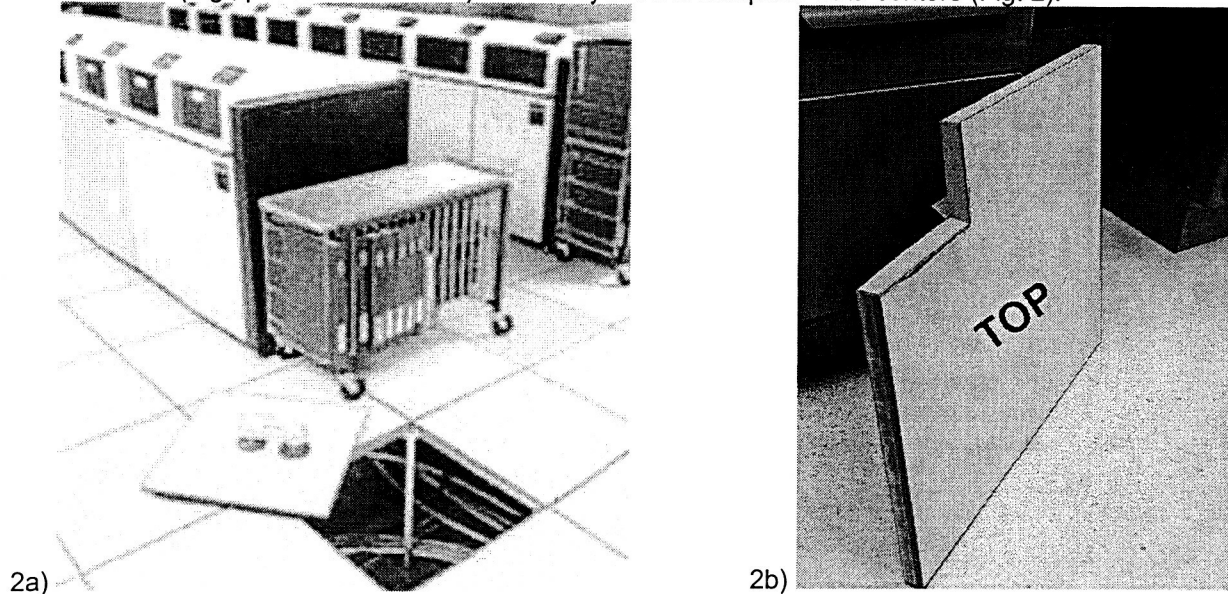
Figure 2: A Typical Raised "Access" Floor System.

- a) A data center floor system with one tile lifted illustrating that the floor is raised and supported by pedestals and stringers to facilitate under-floor cable routing. The sub-floor space is also used as an air plenum.
- b) Top/side view of one type of access floor tile. This tile has been cut revealing a vinyl top surface attached to a 1-inch thick wood fiber core onto which a thin sheet of zinc-electroplated steel has been glued to the bottom and sides.
